## MAIN STREET SIGNAGE

### Property Brokers - 2 Hastwell St Illuminated Signage

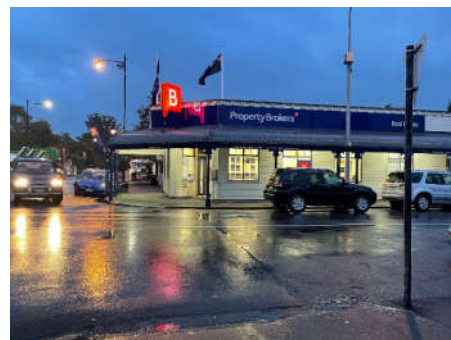
The Greytown Heritage Trust ("the GHT") notes that there appears to be no resource consent which covers signage for the building at 2 Hastwell St (corner Hastwell and Main Streets). The additional illuminated signage to the verandah roof was added at a later date (after such time that the Greytown Heritage Trust complained about the colour scheme).

This illuminated signage clearly contravenes the Wairarapa Combined District Plan Appendix 8 – South Wairarapa Town Centers Design Guidelines 35.1.8 Signage in most respects:

- The sign is not sympathetic in scale, colour and design with amenities and historical qualities of the area.
- The brackets are not an integral part of the sign.
- The sign is illuminated which would seem worse than being painted in fluorescent colours.
- The sign is fixed to the verandah roof and describes the Property Brokers Brand. The intention of the design guide is that any signage fixed to the verandah will be below the verandah level.
- The illuminated sign dominates the building's character and will be the only illuminated sign (above verandah) continuing to operate once the proposed work at the Workingmen's Club is undertaken.

With regard to 21.1.3 (b) Historic Heritage Precincts that Signs within the Commercial and Industrial Zones in the Historic Heritage Precincts:

- The illuminated sign appears to exceed the maximum size allowable for a sign (see below).
- The sign is internally illuminated rather than illuminated by directional lighting. We note that this type of lighting is not consistent with the Dark Sky lighting requirements.
- The sign is located above a verandah and extends well above the parapet height.
- We also note that 6.5.2(f)(i)(7) of the Wairarapa Combined District Plan requires that any illuminated sign visible from the Residential Zone shall not be lit unless the premises are open for business. This is also not being adhered to.

The sign is clearly inappropriate in the Historic Heritage Precinct, we would like to see this sign removed.

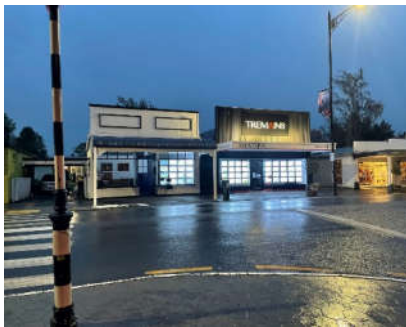
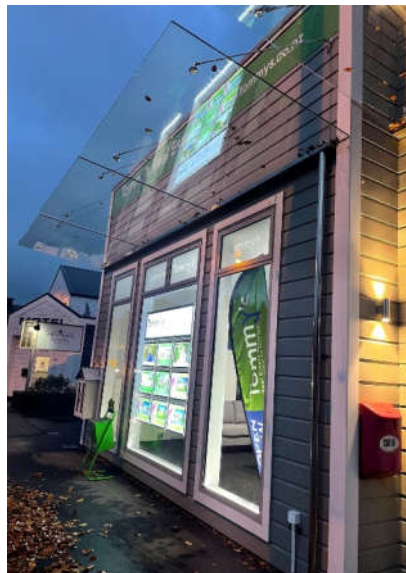
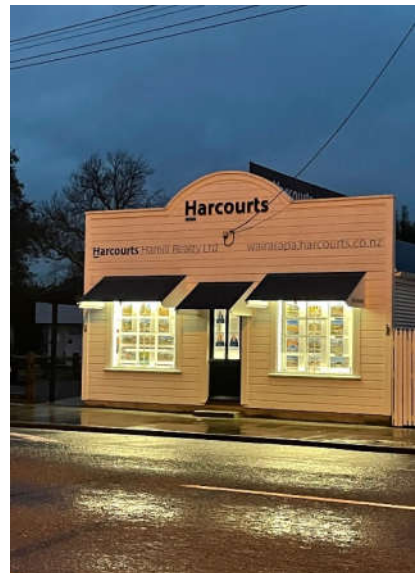
We are concerned with the degree of illumination to the real estate shopfronts, particularly those which have self-illuminated signs. The high degree of illumination makes them appear as a single illuminated sign and they are not in sympathy with the scale, colour and design of other retailers in the area who use traditional window display illumination. These multiple small self-illuminated advertising are contrary to the Wairarapa Combined District Plan Appendix 8 – South Wairarapa Town Centers Design Guidelines 35.1.8 Signage with them not being illuminated by directional lighting and them being visible from Residential zones. While each of these signs is small, their combined effect is of one huge sign (again contrary to the guidelines). (We note that Harcourt’s are not using self-illuminated signs - they do have an excess amount of illumination).

We would also like to see all self-illuminated 'signs' removed, and unnecessary excess lighting removed.

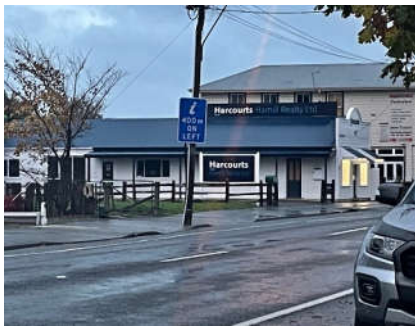
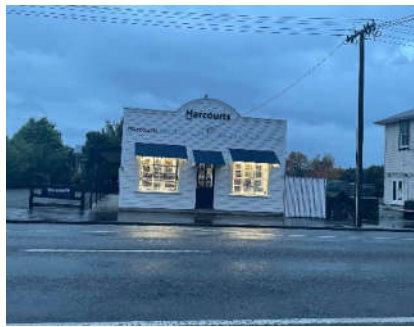
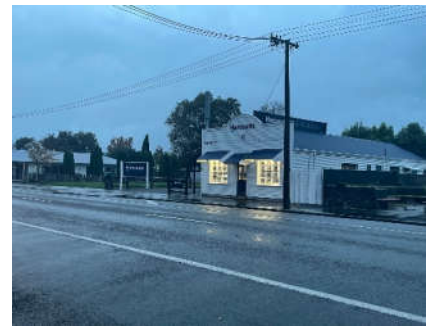
In addition, one of the agents is in a residential area and clearly contravenes the maximum area of allowable signage. We complained about the sign on the roof the of Harcourt's building under the previous tenant.

We would like to see the excess signage, particularly at the Harcourts building addressed (the sign on the roof of the Harcourt's building is particularly inappropriate in the residential zone and if it were in the Town Centre the sign does not align with 35.1.8 (vi) of the South Wairarapa Town Centers Design Guidelines).
