## MAIN STREET SIGNAGE

### Property Brokers - 2 Hastwell St Illuminated Signage

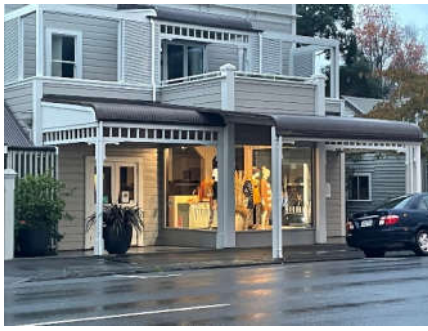
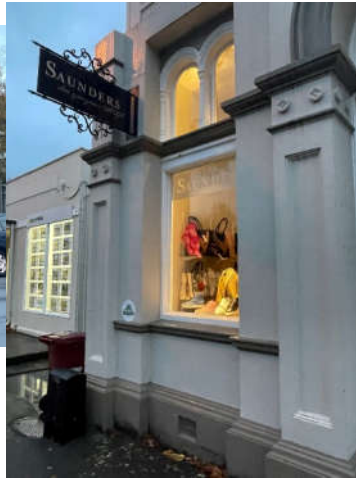
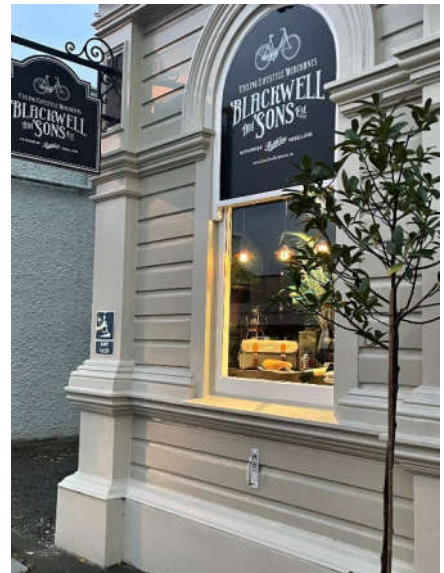
Other retailers:

In addition, one of the agents is in a residential area and clearly contravenes the maximum area of allowable signage. We complained about the sign on the roof the of Harcourt's building under the previous tenant.
